**Project study
of the installation work in Opheimsgata
Odda town centre, Norway**

**Betomur deliverables:
Chembuild bedding mortar
Flowpoint grout**

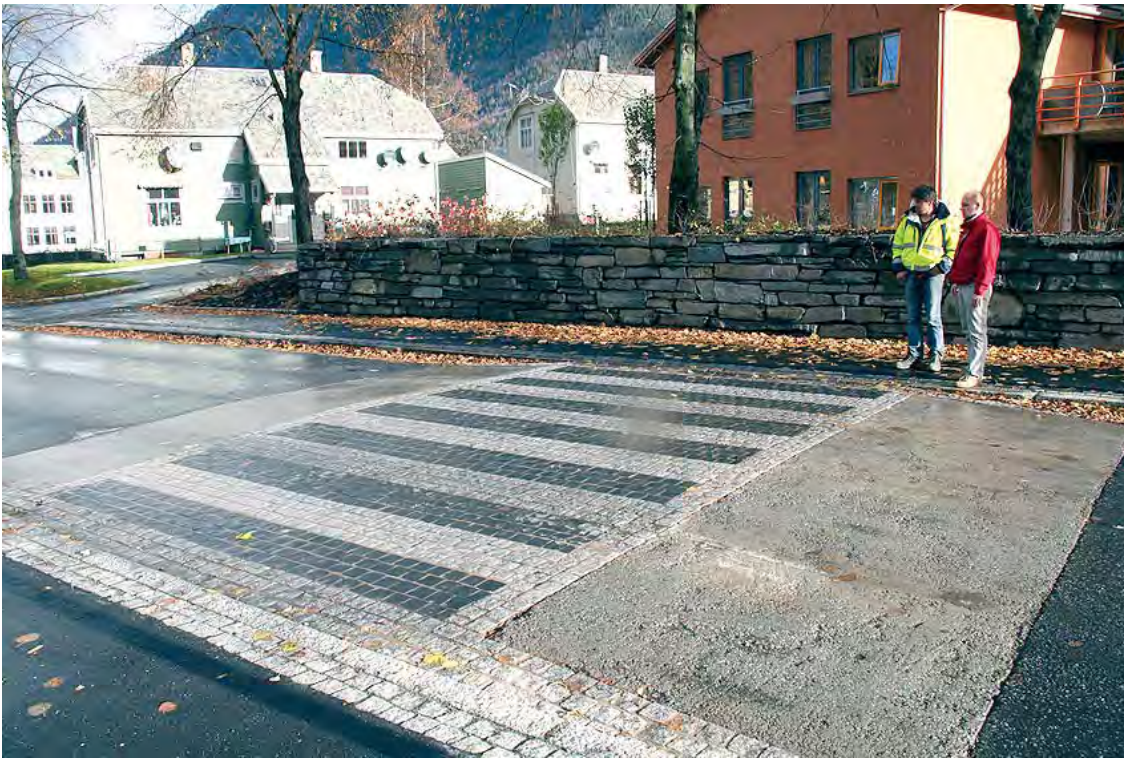
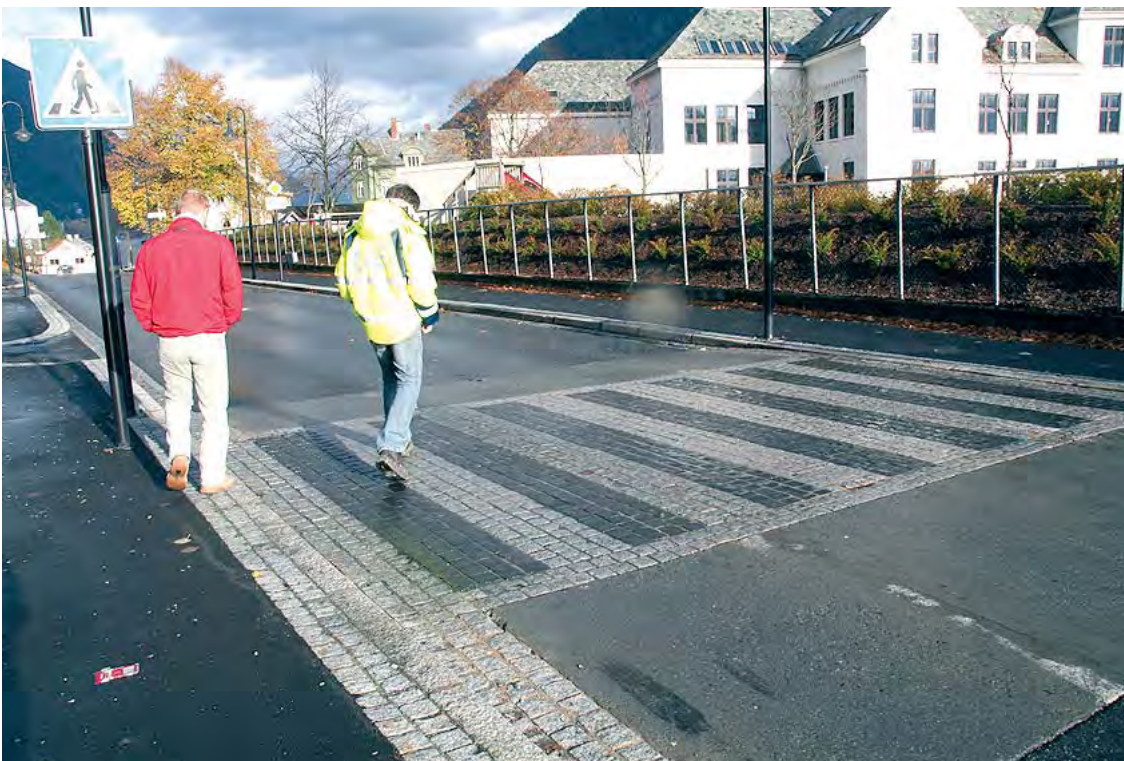
Inspection of the pedestrian crossings after about one year's use. All the crossings were assessed. Opheimsgata has heavy through traffic, with busses and heavy goods vehicles passing through on the main route between Bergen and Oslo. As the photographs show, after one year the traffic has already caused considerable damage to all the concrete ramps at the pedestrian crossings.

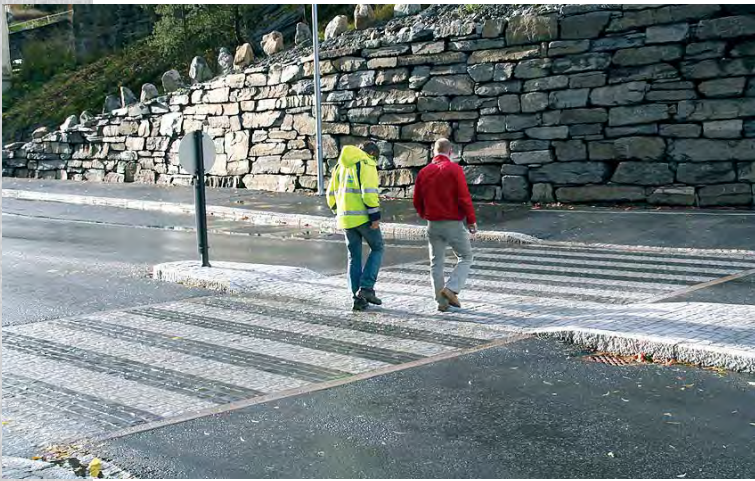
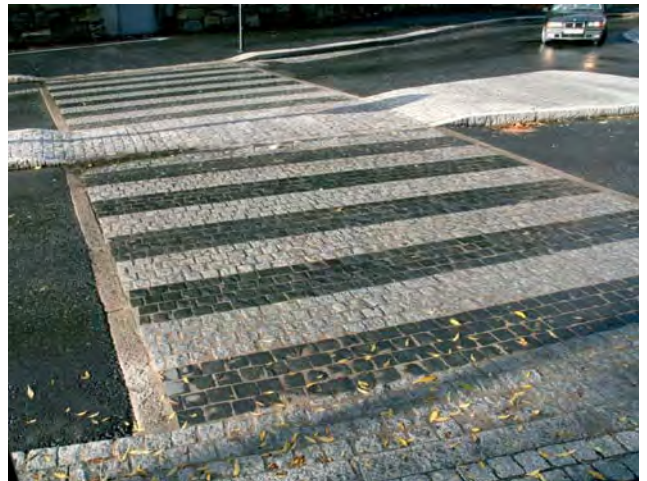
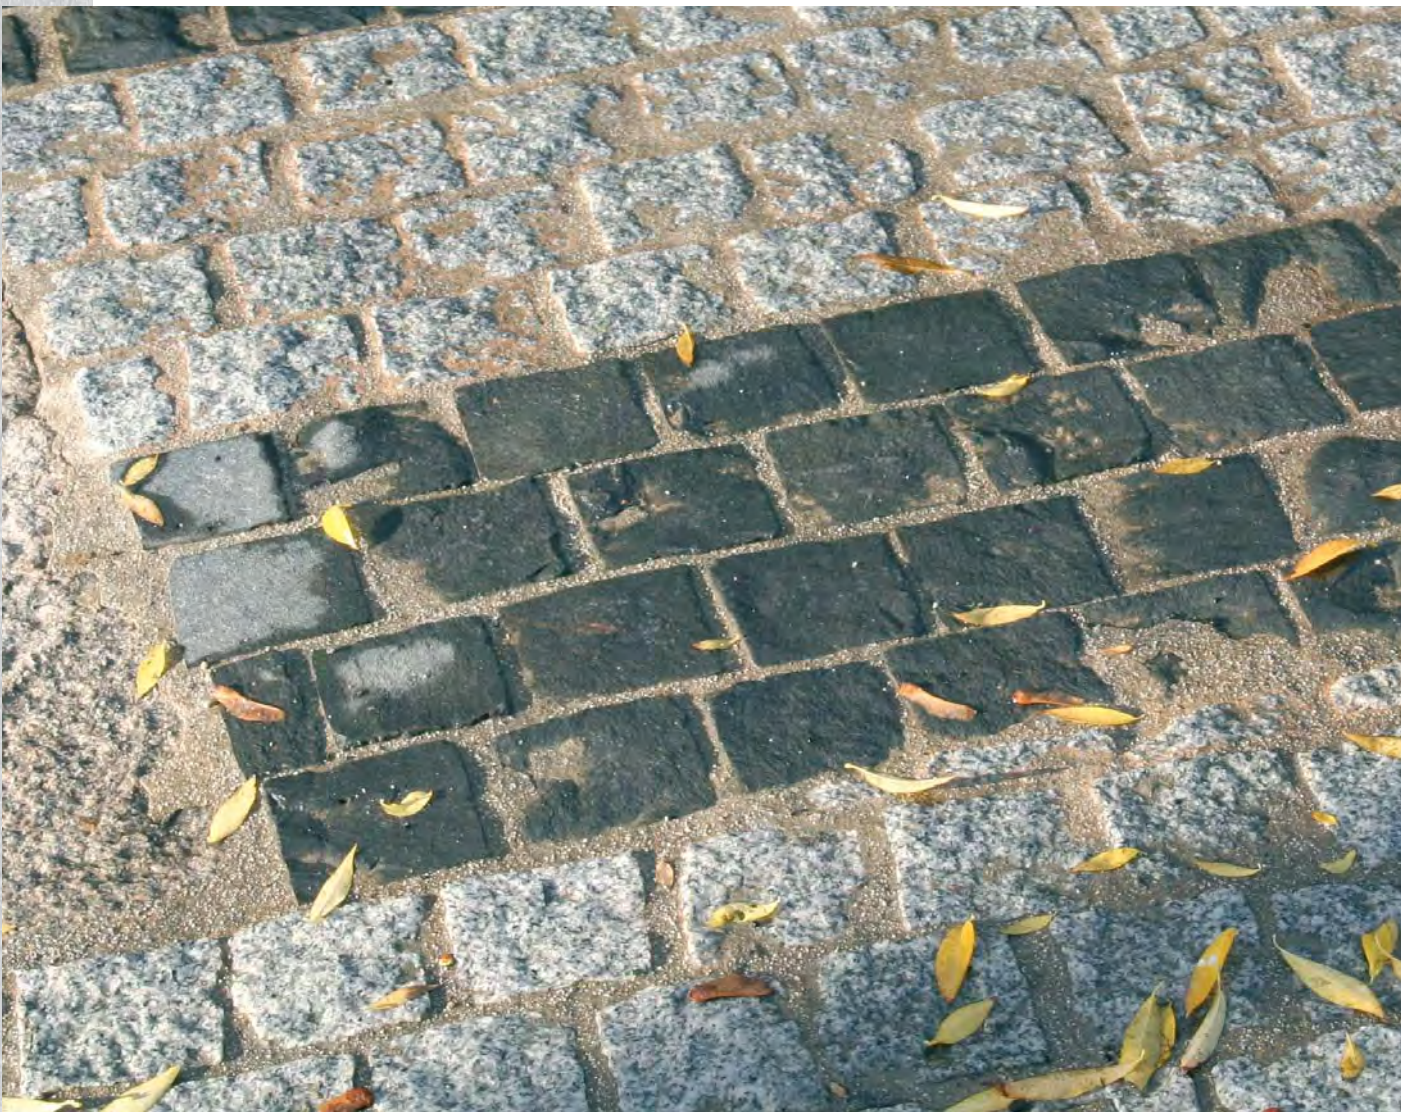
The lowest crossing in Opheimsgata is not raised and therefore does not have concrete ramps. The crossing itself is pointed using Betomur UltraCrete Flowpoint and as the close-up shows, the paving and joints are completely undamaged and show no sign of wear, in spite of the loads to which they have been subjected.

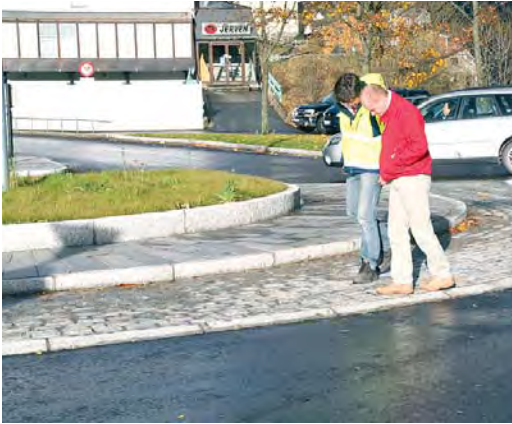
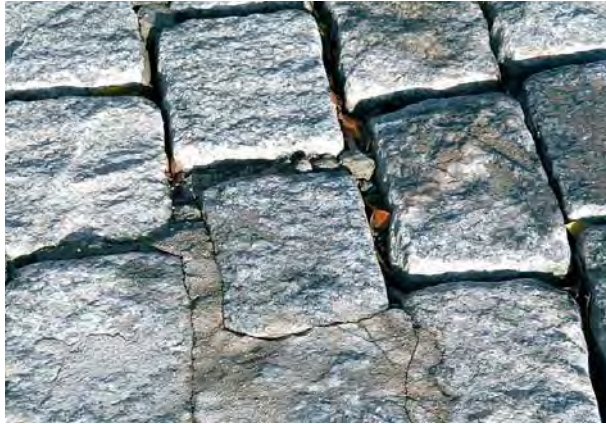
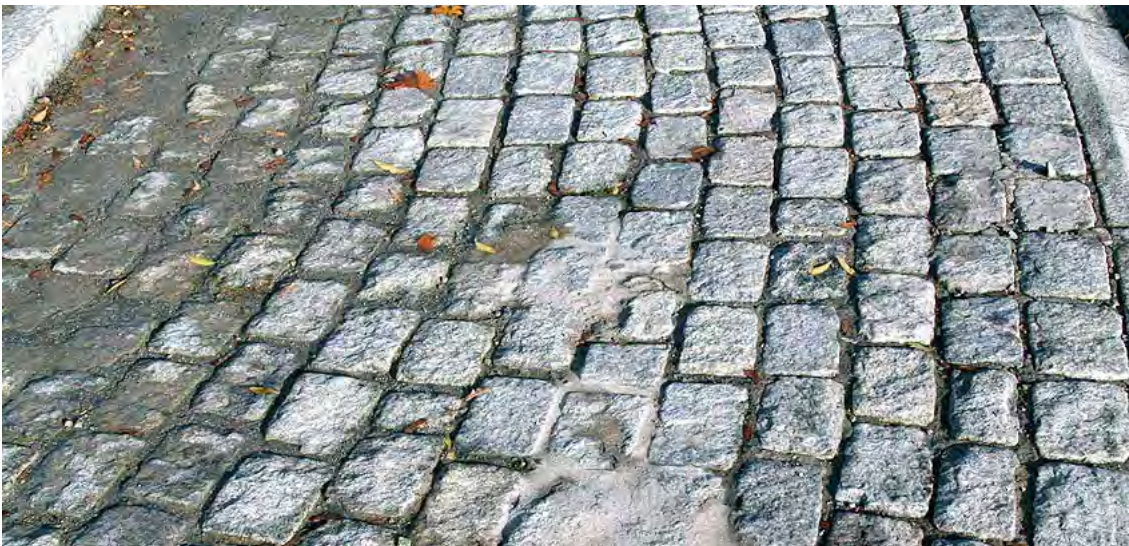
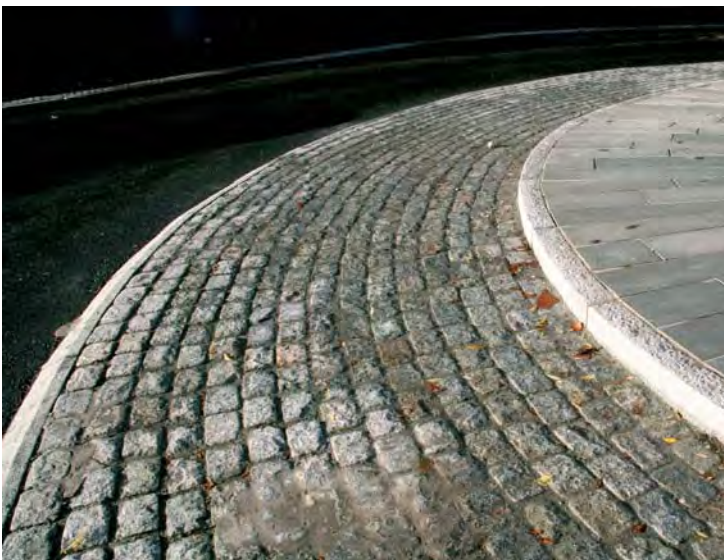
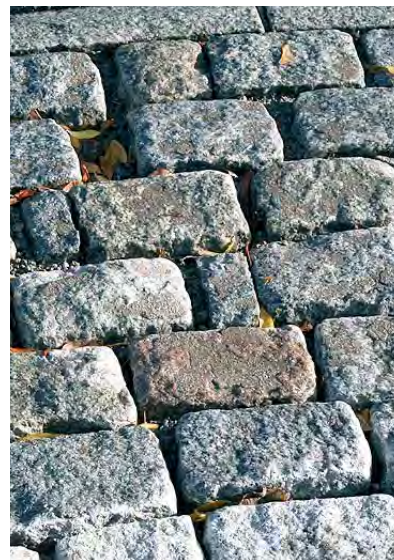
These photographs show a roundabout located about 50 metres from the pedestrian crossings, which was constructed without using Betomur's system. It can be clearly seen that traditional pointing and a repair with different material do not function on similarly exposed surfaces. All the photographs on this page are of the same roundabout.

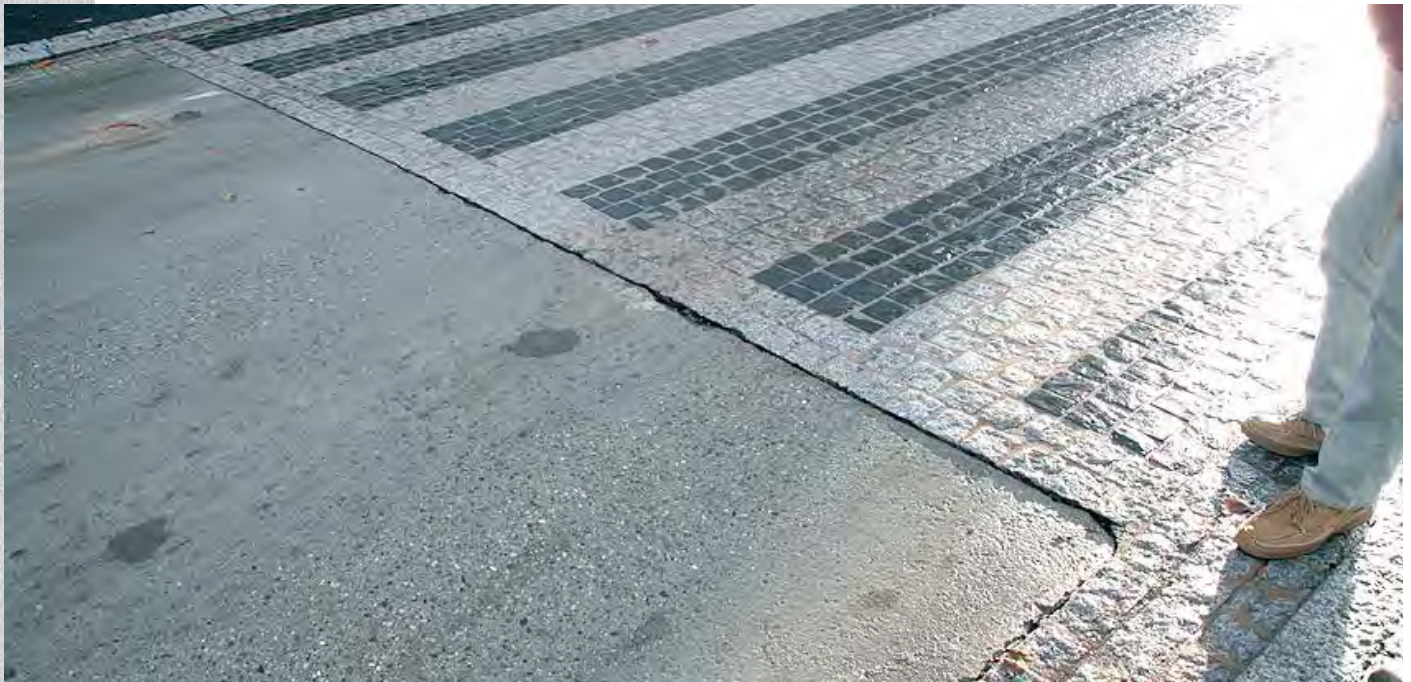
All the concrete ramps have sustained heavy damage, but the poured-in-place ramps were affected less than the prefabricated elements. All the pedestrian crossings were undamaged, and what is most impressive is that although the concrete ramps are worn, cracked or subsided, the Flowpoint grout and natural stone remain completely undamaged ALL THE WAY TO THE EDGES!

This appears to be a good method for constructing a pedestrian crossing, the only weakness being the concrete ramps which lift the vehicles up onto the crossing. These should have been constructed more solidly.

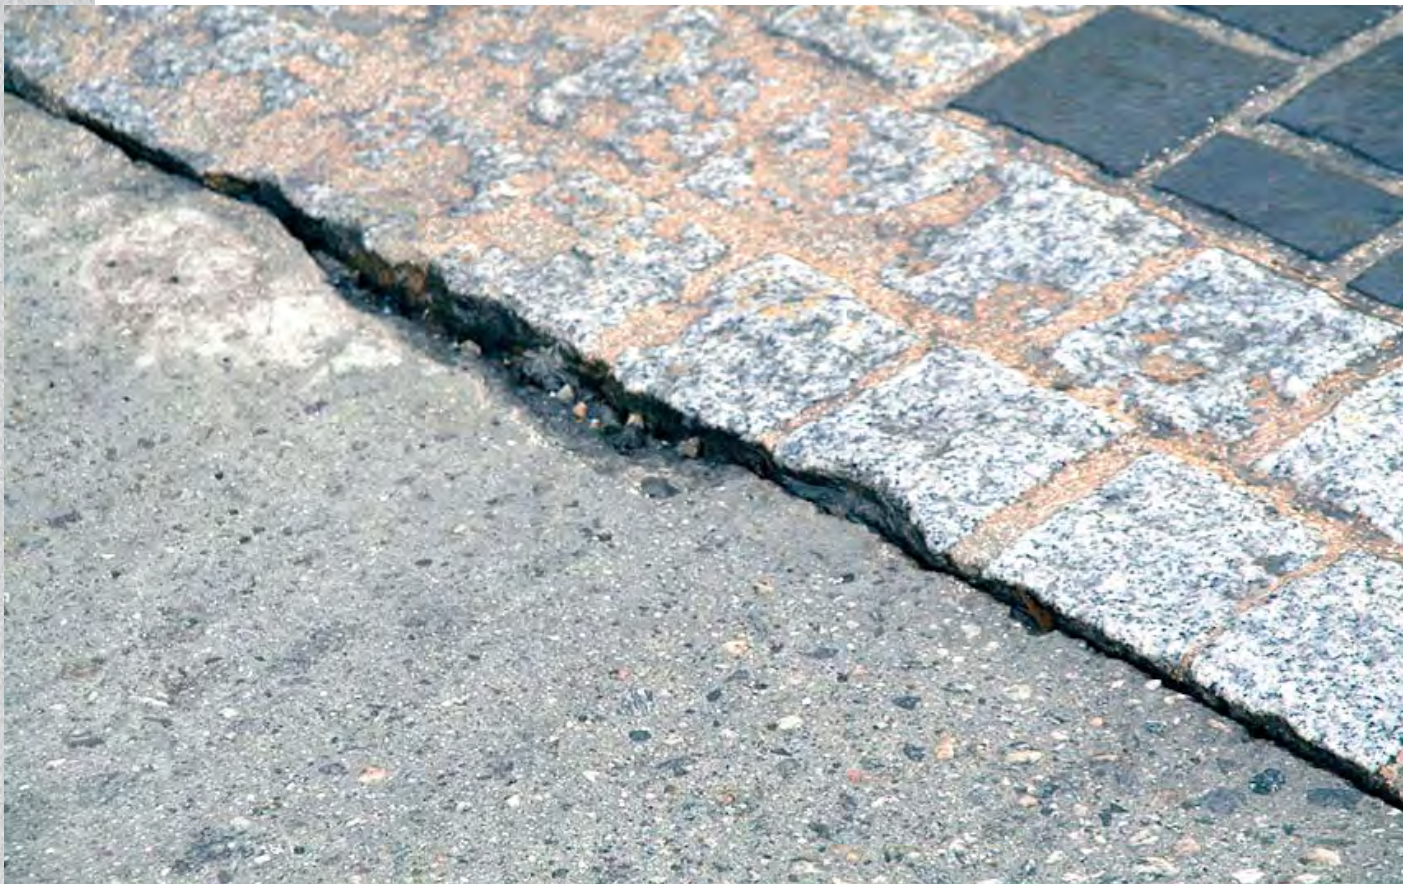
*This concrete ramp rocked about 1.5 cm each time a vehicle passed!
The natural stone and grouting remained firm and undamaged.*

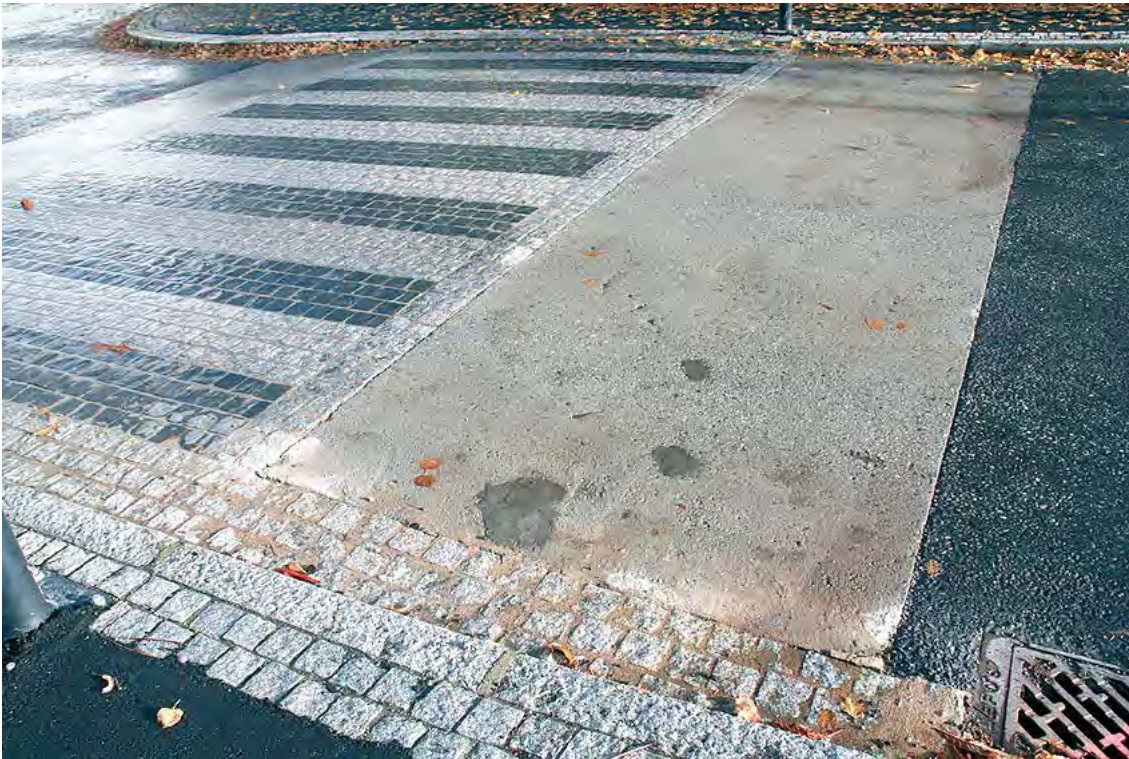
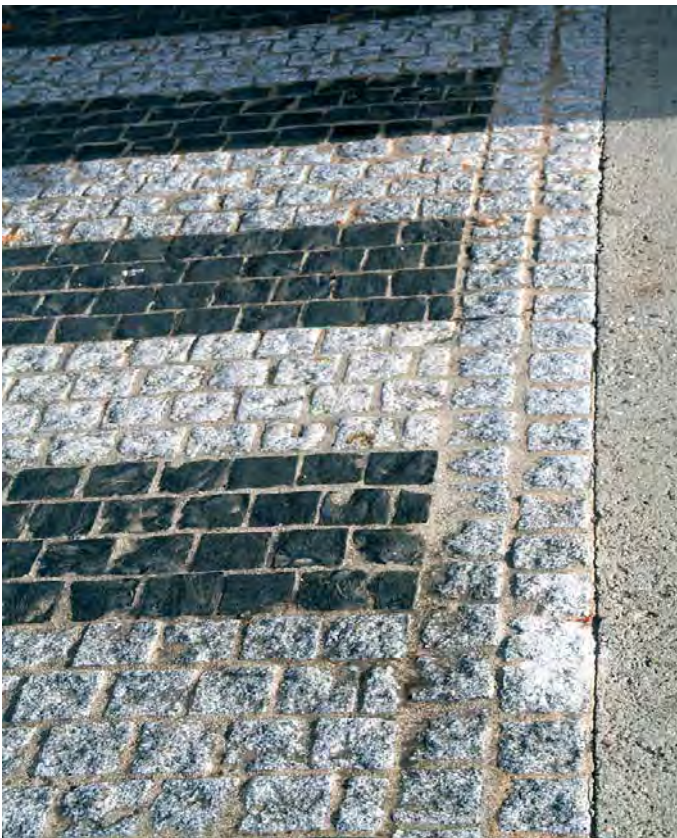
The crossings are made of attractive stone, transitions are smooth and ensure pedestrians walk on an even surface.

However, the impression is considerably impaired by the appearance of the ramps.

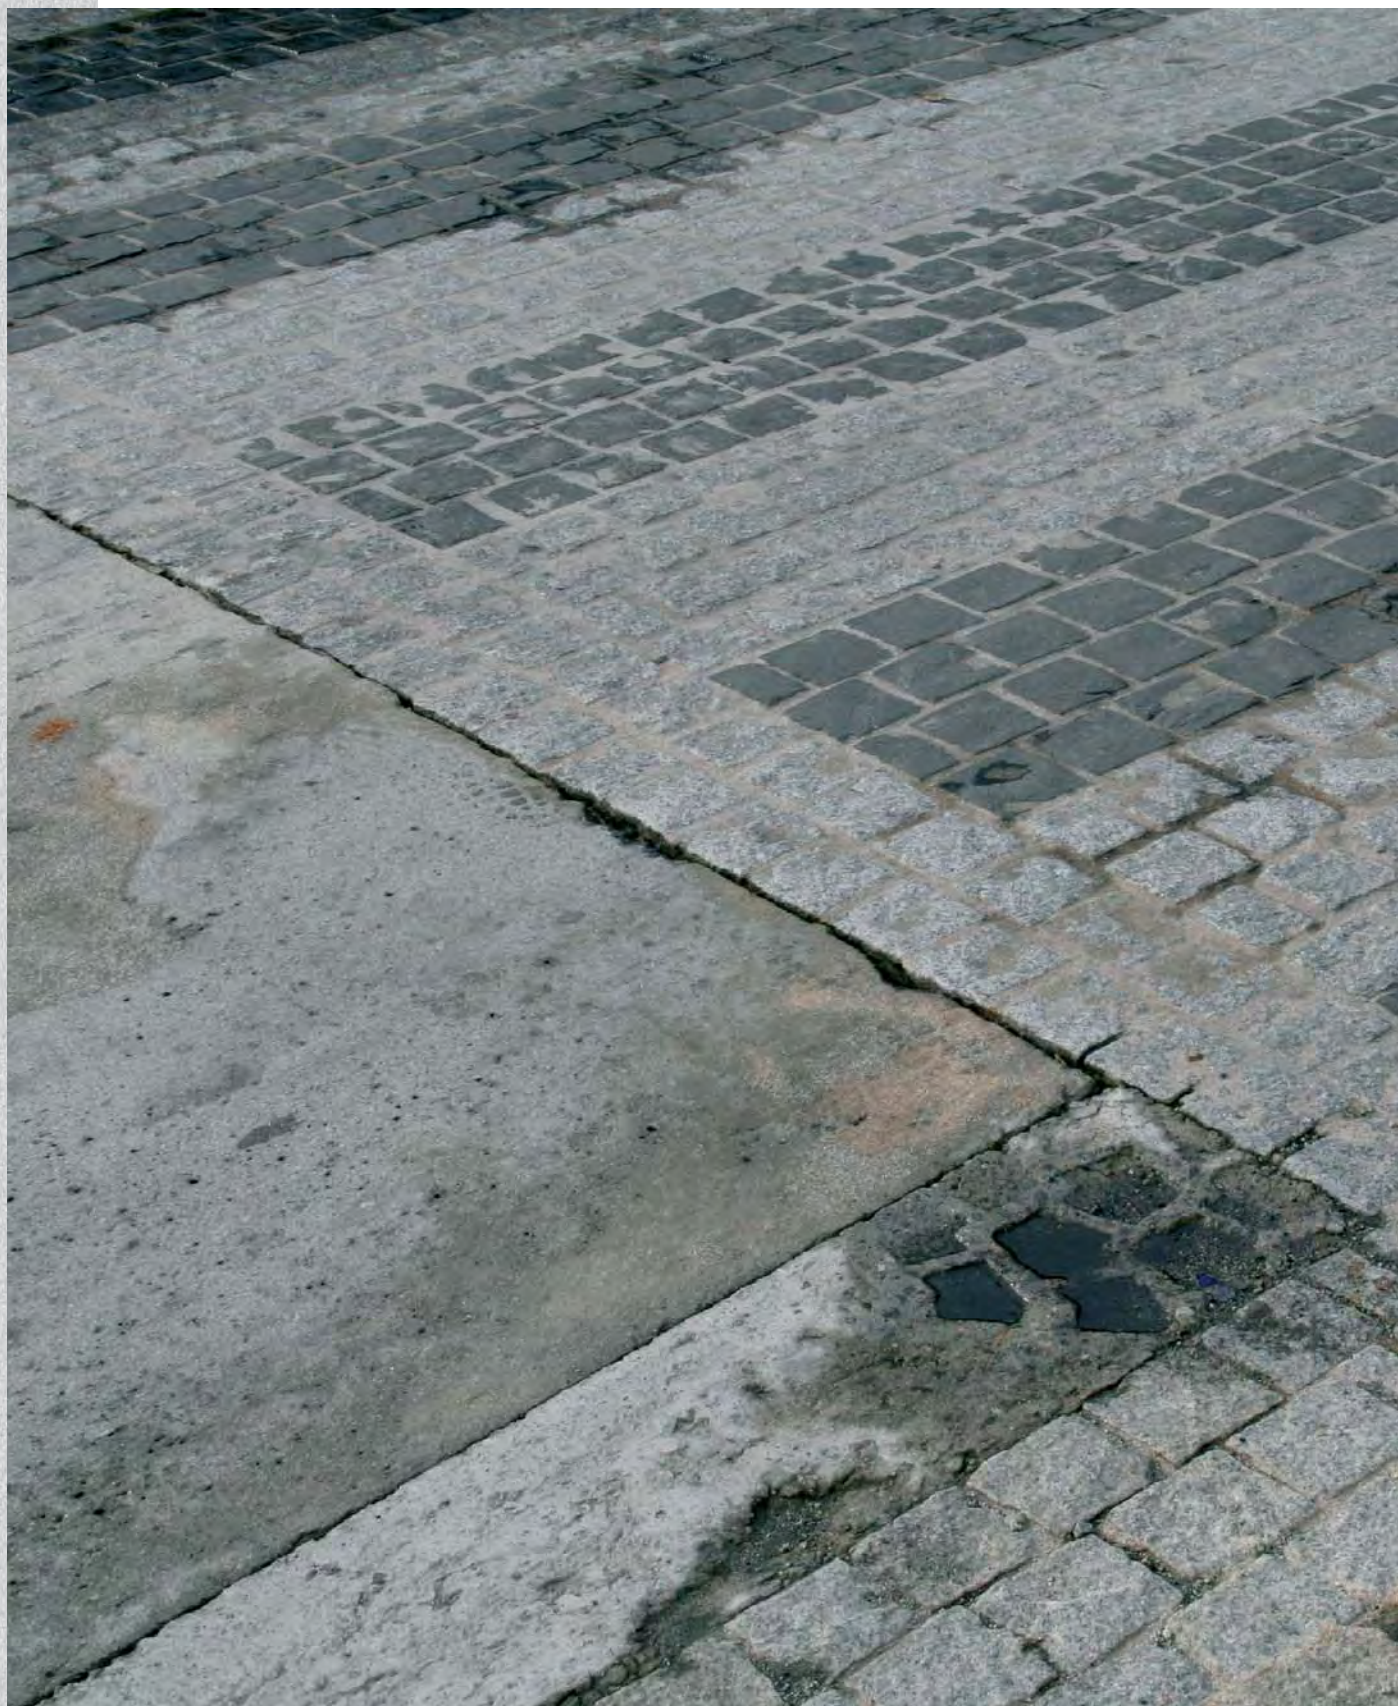
It was not difficult to see where the best investments had been made ...

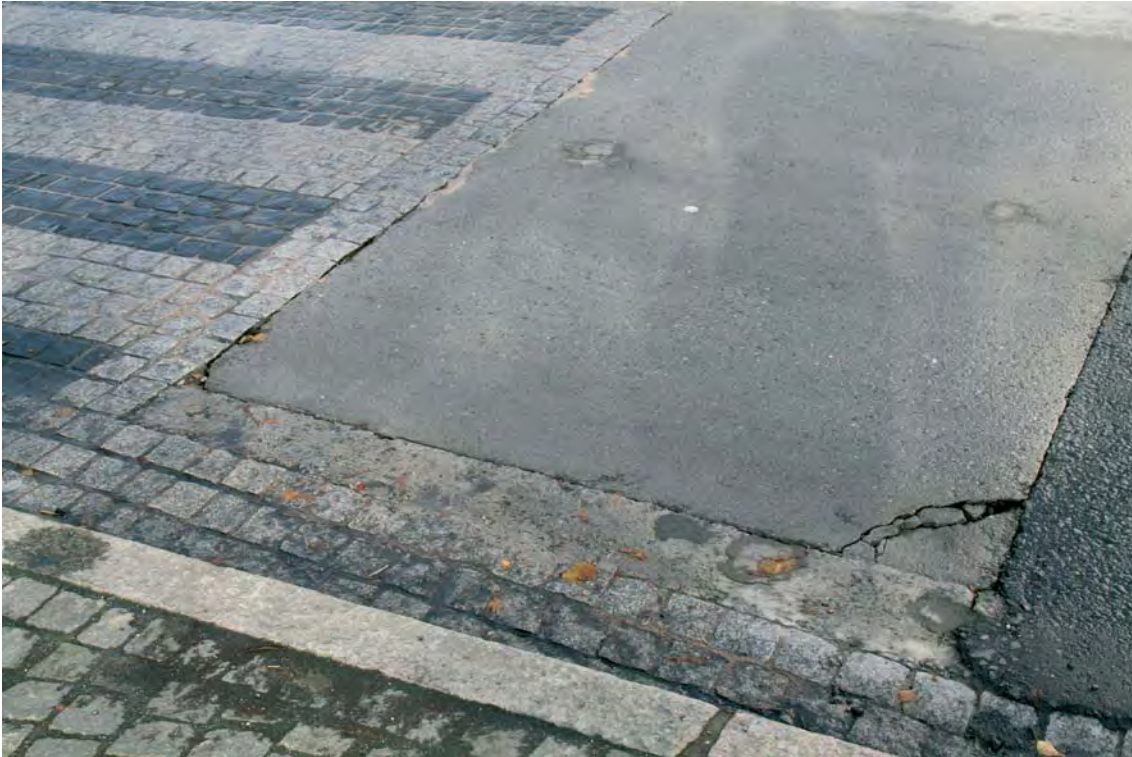
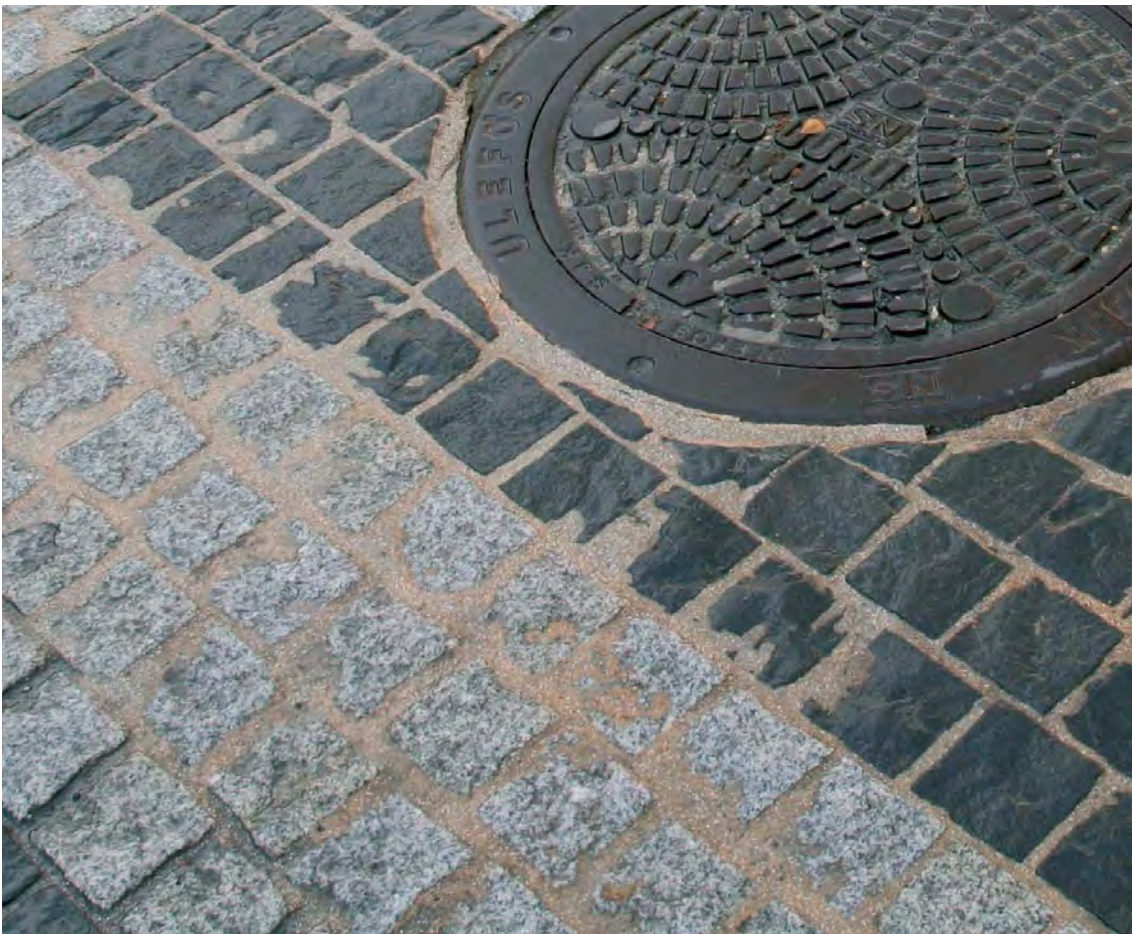
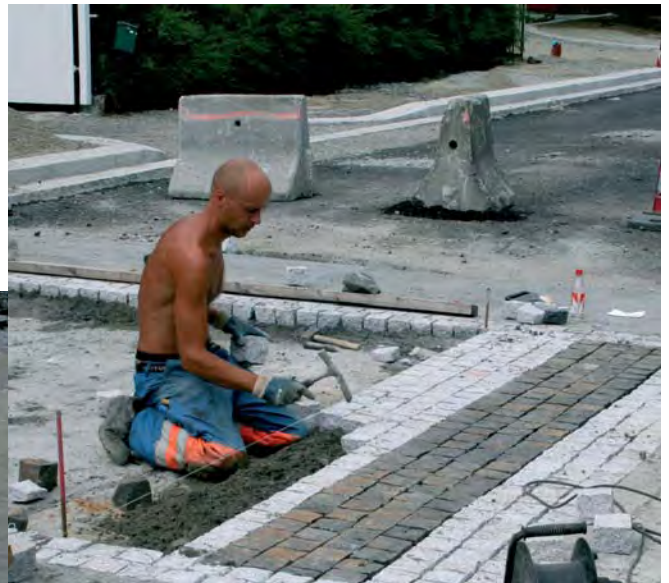
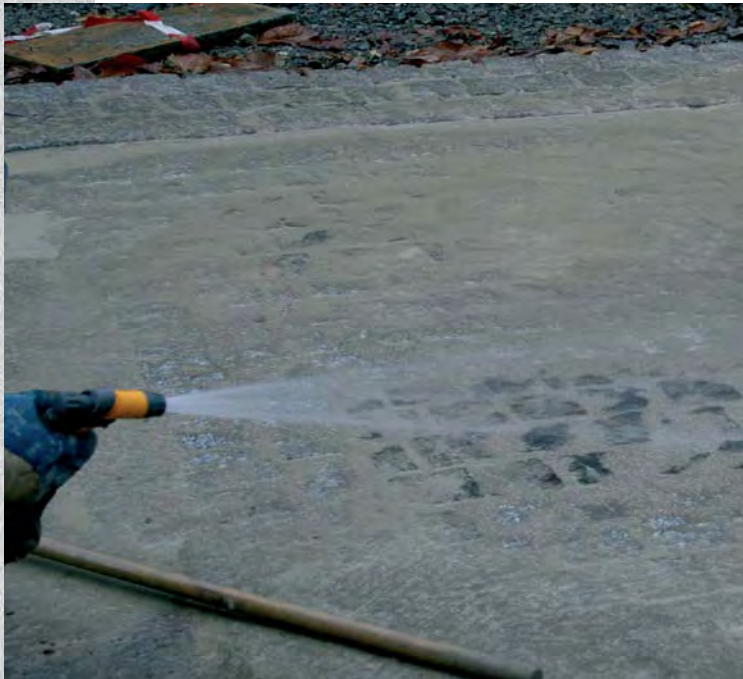
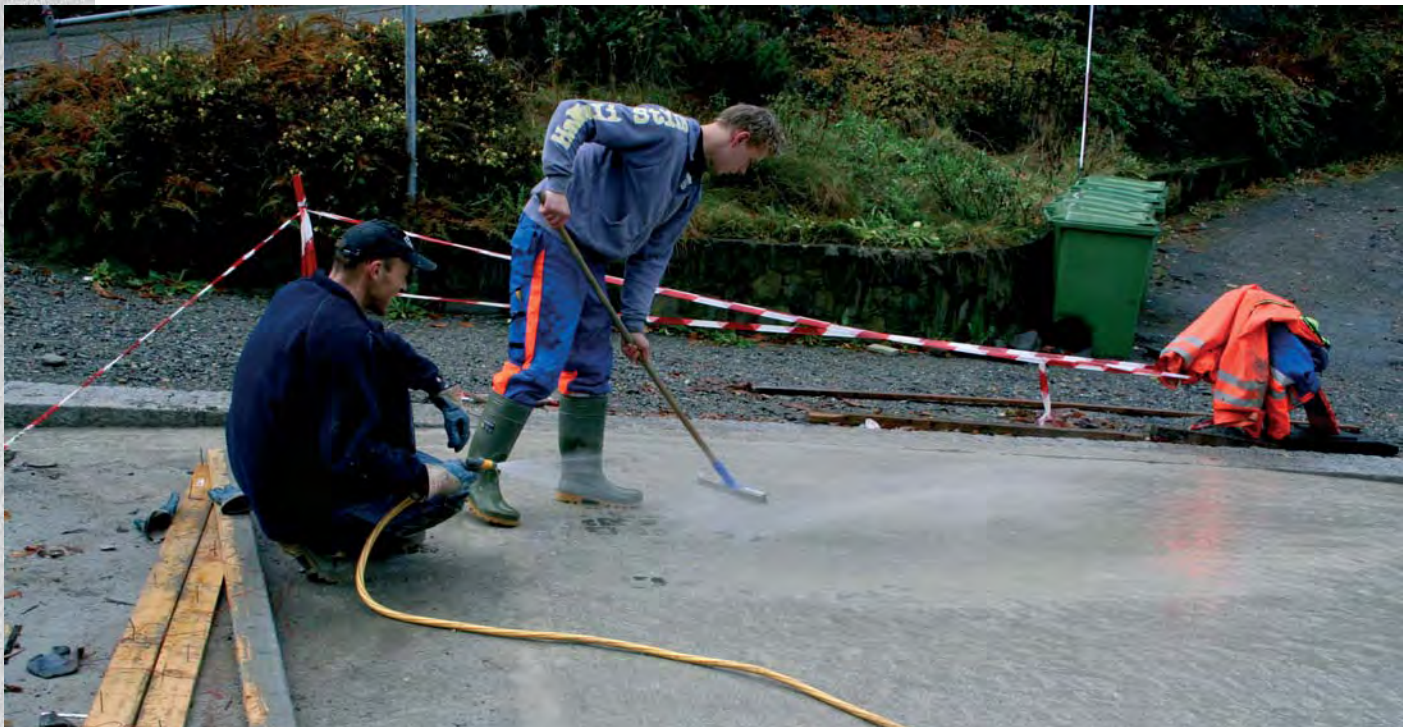
Photographs showing the actual setting and jointing with Flowpoint. The photographs show how the crossing is installed on a concrete bedding before the stone is laid in Betomur's UltraCrete bedding mortar.

The installation is then pointed using Betomur UltraCrete Flowpoint, which is poured over the stones so that it runs into all the joints and crevices.

After a few minutes the surface is hosed clean and the job is done!
